# ► Institutional review in preparation for improving access to TVET programmes for persons with disabilities who have been internally displaced

Final report submitted to the  
International Labour Organization (ILO)  
Submitted by the Ethiopian Center for  
Disability and Development (ECDD)

October 2020

### ► Physical accessibility audit of Jigjiga Polytechnic College

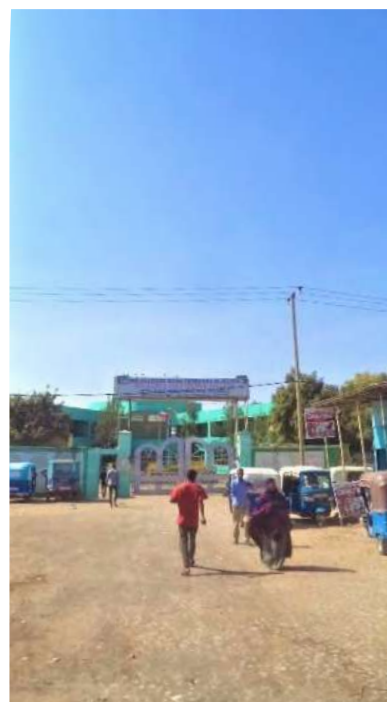
The pedestrian access is normally open. It serves as the entrance and exit for the college community and for visitors. This door is 0.85m wide and 2.40m high. It has no lighting system.

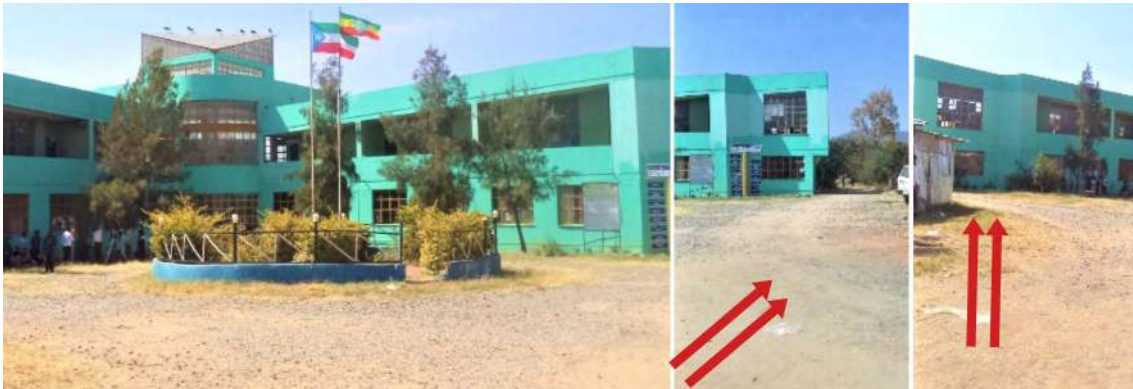
The surface of the courtyard is not level. There are no designated pathways to the buildings and service windows. Immediately beyond the entrance there is a sign board; this is not centrally located for all to see but stands away to the right. The surface of the courtyard is rough, with pieces of stones lying around. There is a car-parking area, but it is not signposted. Moreover, there are no designated car parking spaces for persons with disabilities.

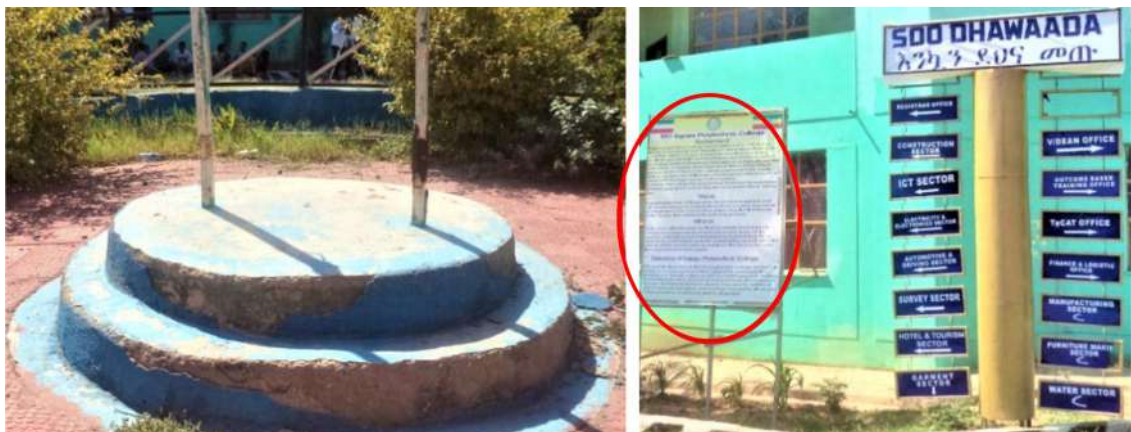
The sign board is between 0.15m and 3.00m in height. The font size is too small for clarity.

- The threshold needs to be removed and clearly signaled. Its height should not exceed 0.013m.
- Steps should ideally be replaced with ramps (5% gradient, with 0.90m upper and 0.70m lower hand rails extending 0.30m beyond the start and end points of the ramp); alternatively:
- The steps should not be more than 0.15m in height, with a tread width of no less than 0.35m.
- Signs and notices should always be accessibly positioned and clear, with a large font size used for the lettering.

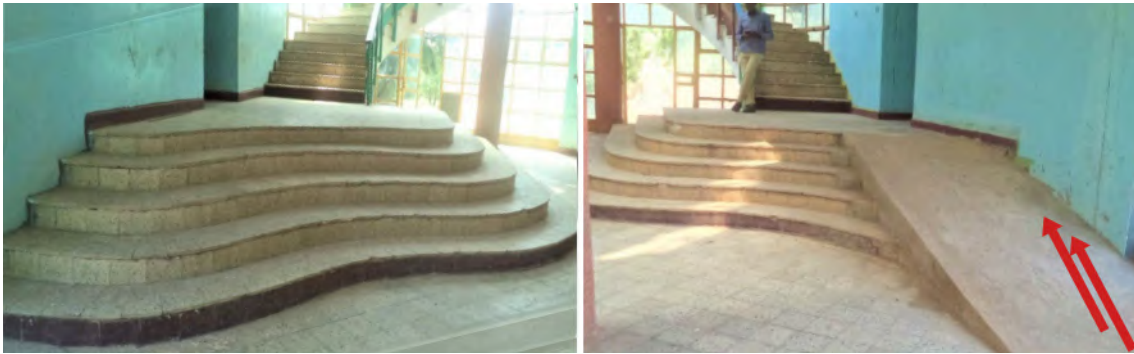
The ramp giving access to these workshops and offices is well constructed and slip-resistant. It has a gradient of 20.7% (3.70m long for a rise of 0.75m and 1.45m wide). The ramp has no handrail, kerb stones or signage.

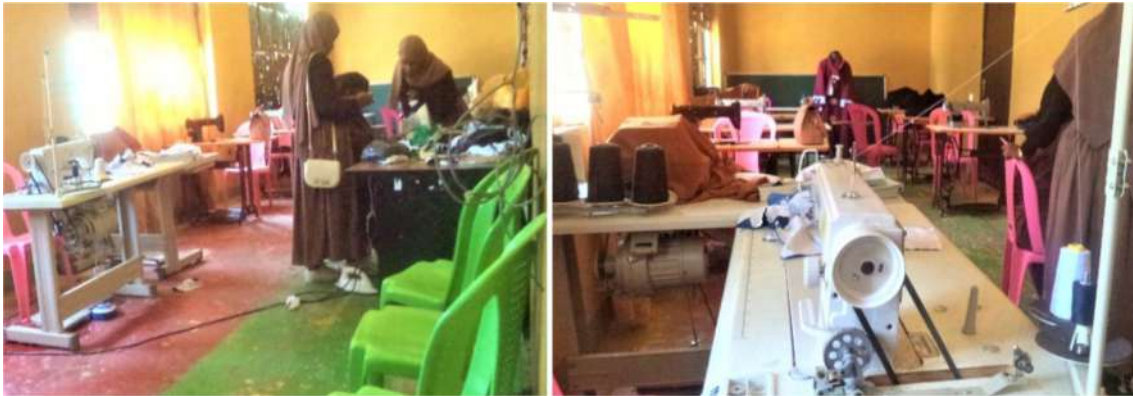
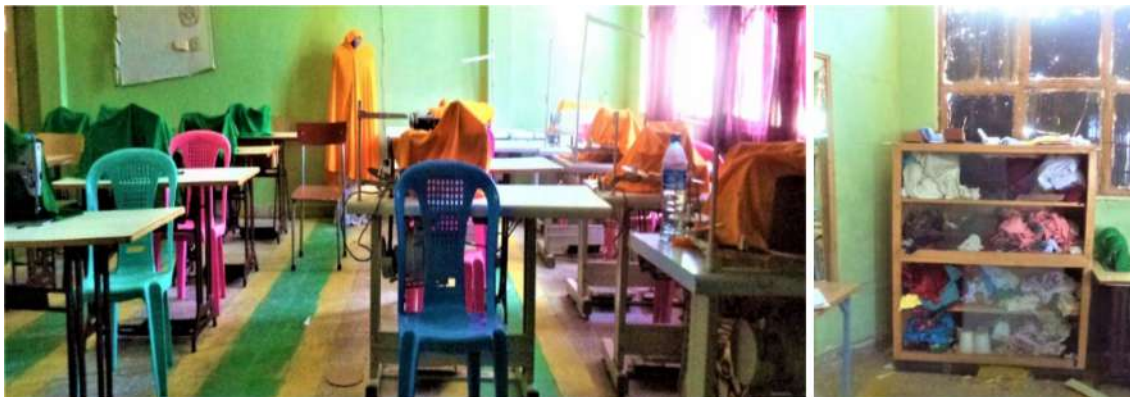
## Access to the garment workshop

The room is centrally located at the end of the corridor. It has double doors, each 1.02m in width. The height of the chairs is 0.42m, while that of the sewing-machine tables is 0.75m. The lighting is functional. The supervisor's table is 0.66m in height, with space for the user's knees.

The open shelving is 1.50m in height, and there is a greenboard located at a height of 2.21m. Along this corridor, there are 13 rooms of the same size and design.

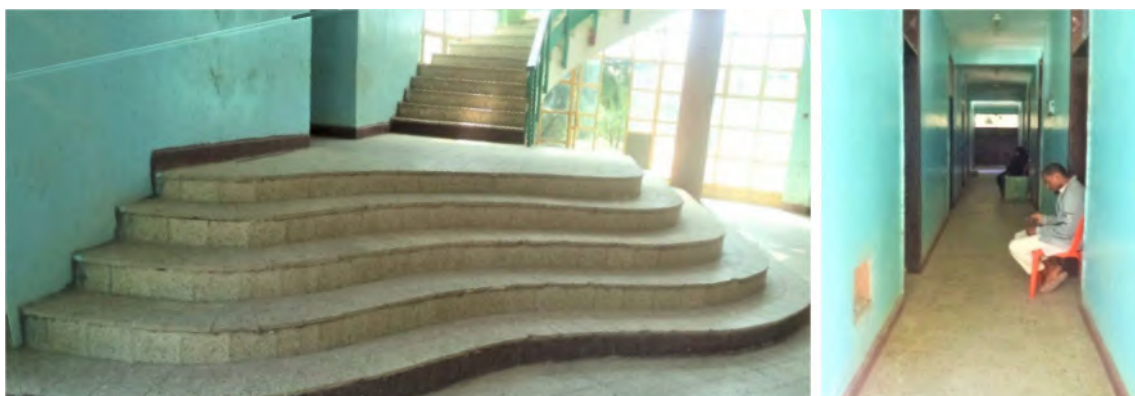
The corridor is accessed via a staircase with five steps, not with a ramp as on the other side. The steps have a tread width of 0.30m and a height of 0.14m, with no handrails or kerb stones. The corridor has no functional lighting system and as a result is rather dark.

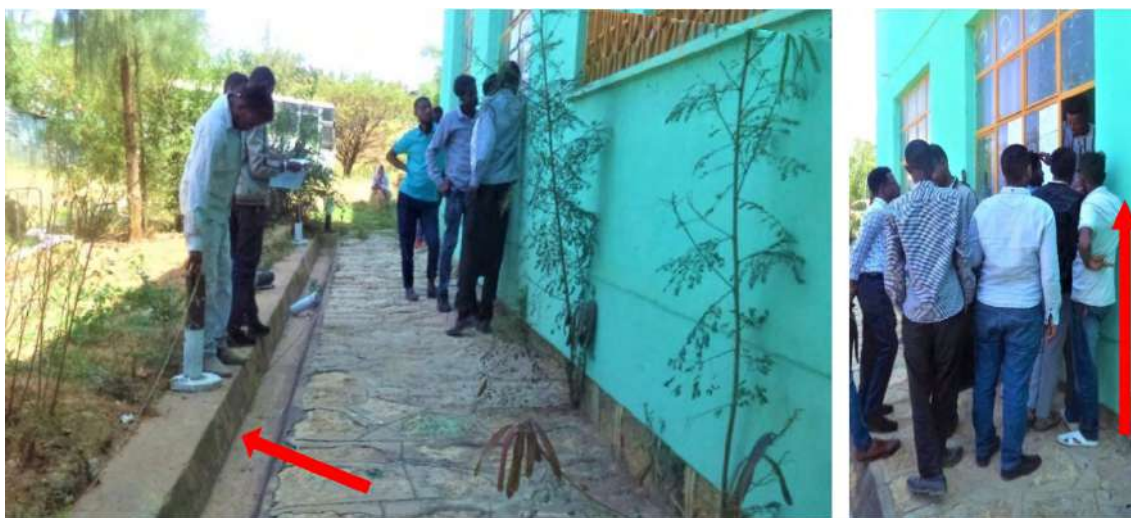
## Access to the Driving-License Service Room

Although the room is situated under the building to the left of the corridor, the students have been accessing the service from the outside via the window. This window has no clear signage or proper access. The pathway to it has a kerb on the side away from the building, 0.19 m in height, designed to retain a garden area. The pathway is not entirely level. The service window is 1.35m above the ground.

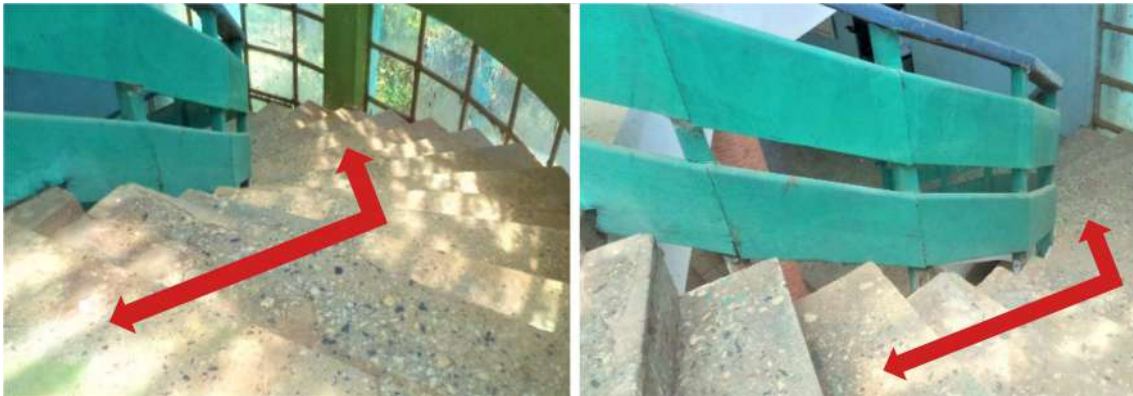
The first floor is accessed by two staircases of 19 steps, which are 0.20m in height and have a tread width of 0.30m. The stairs have handrails with a height of 0.80m on either side. The handrails measure 0.10m by 0.04m and are rectangular in shape. The staircases are circular and the tread width of each step varies from 0.34m to 0.50m.

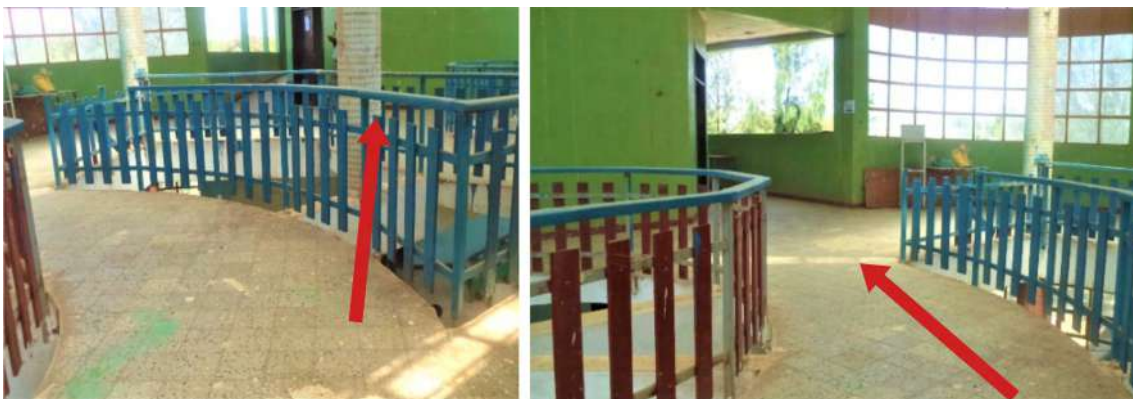
The first-floor corridors are level and made of slip-resistant materials. The signage is inadequate. The corridors leading to the various rooms are 1.85m in width.

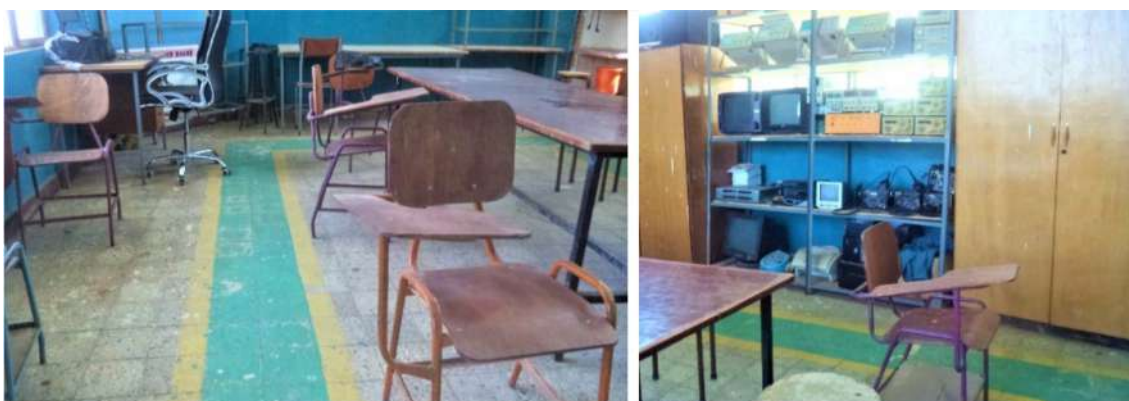
The access way to the workshop is firm and level, 1.85m in width, but lacking clear signage. The door is 1.42m wide and 2.07m high. This is a double door and the handle is located at a height of 1.07m. The chair seats are 0.43m high and the tabletops 0.73m from the ground. The greenboard is located on the wall between 0.87m and 2.07m above floor level. The light switch is located at a height of 1.50m and functions well. The shelves are located at the height of 2.10m.

The first-floor rooms on the other side of the building have not been well maintained and most of the doors and chairs are broken.

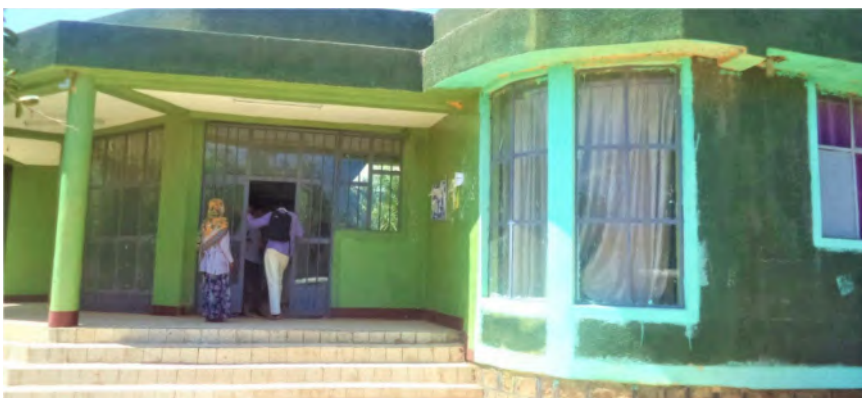
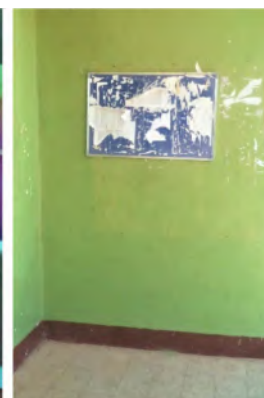
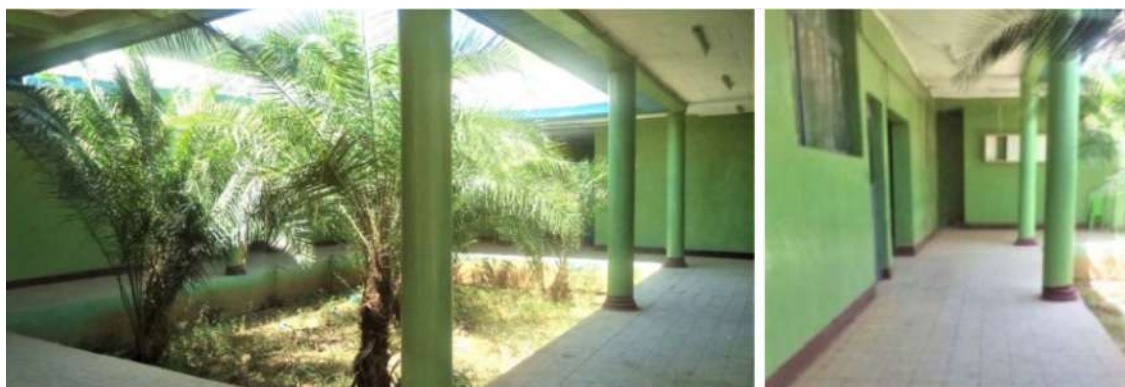
The access ways inside the building are 1.80m wide and are inadequately lit. The walkways have no kerbs or handrails. The building has no stripes at the edges of the pathways to guide people with visual impairments.

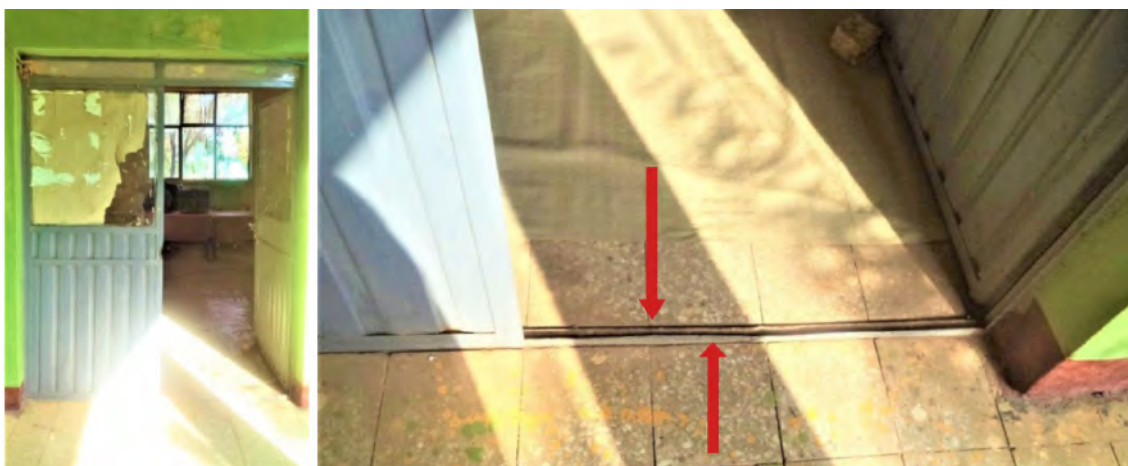
Jigjiga Polytechnic College Finance Office is located at on right-hand side of the compound, reached by passing through the car parking area and a grassy area approximately 100m from the gate. The door has no signage above it. The double doors are 1.62m in width (0.81m for each door). There is a threshold 0.02m in height. The room is light enough, but the lighting system is not functioning well. The switch is situated at the height of 1.30m. The manager's table and chair are 0.76m and 0.42m from the floor respectively.

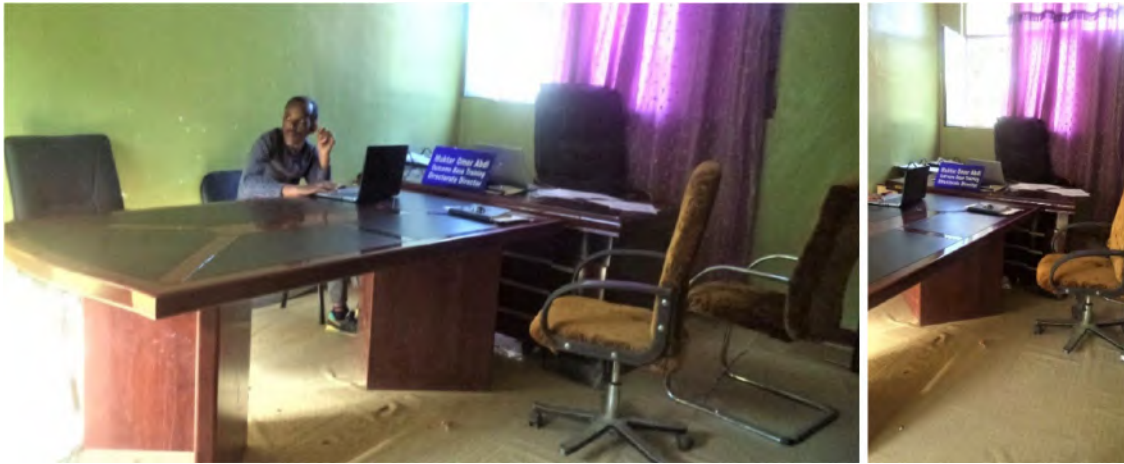
## Access to the Outcome Base Training Office

The Outcome Base Training Office room has no clear exterior signage. The door, which is 0.73m wide and 2.00m high, has a 0.05m-high threshold. The room is well enough lit and has a functional lighting system. The light switch is located at a height of 1.30m. The door handle is located at a height of 1.17m above floor level. The guest chairs are 0.43m in height, the tabletop 0.73m above the ground.

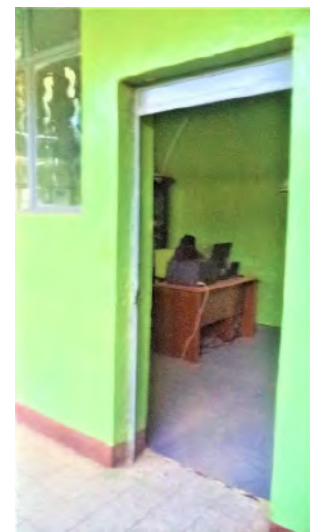
The door to the office of the HR chief is 0.82m wide and 2.00m high, with the handle located 1.07m above floor level. The chairs are cushioned and the seats are 0.42m in height. The tabletops are 0.73m in height. The room is well lit and has a working lighting system. The light switch is located at a height of 1.20m.

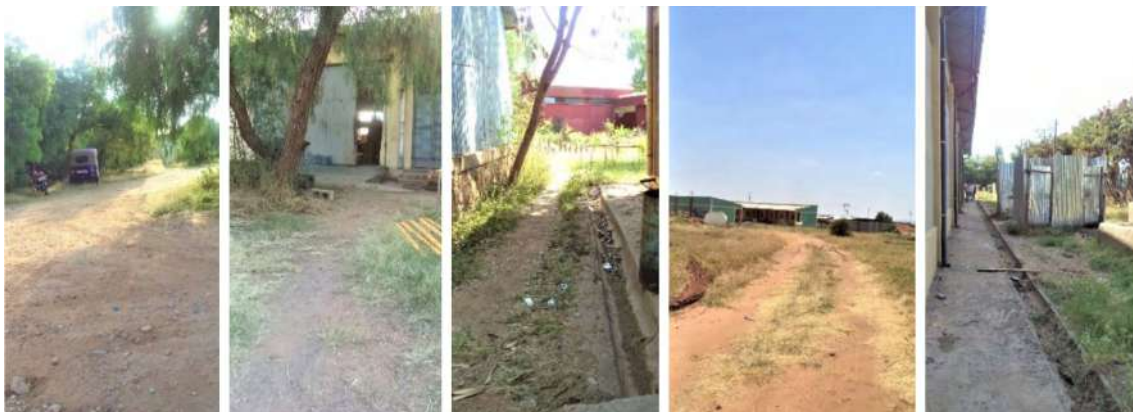
Most of the pathways are not well laid out for visitors and students with disabilities: they are not level and lack clear signage.

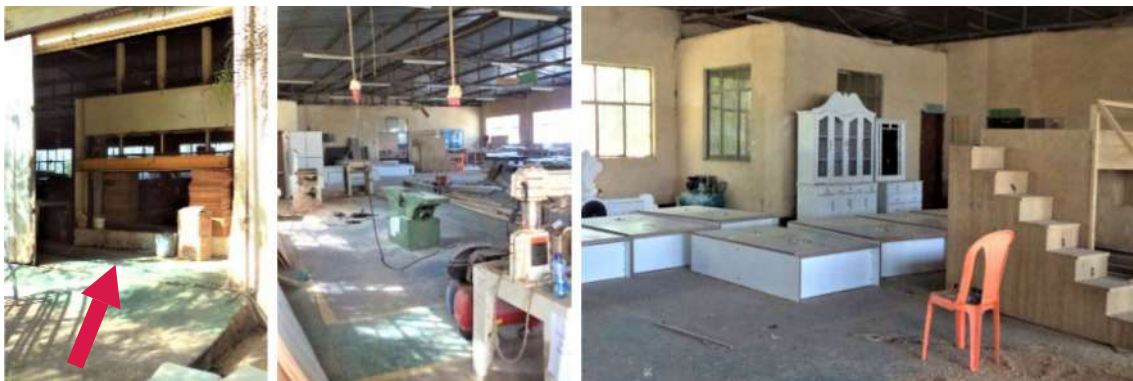
Inside the workshop itself, there are no clear signage or instructions.

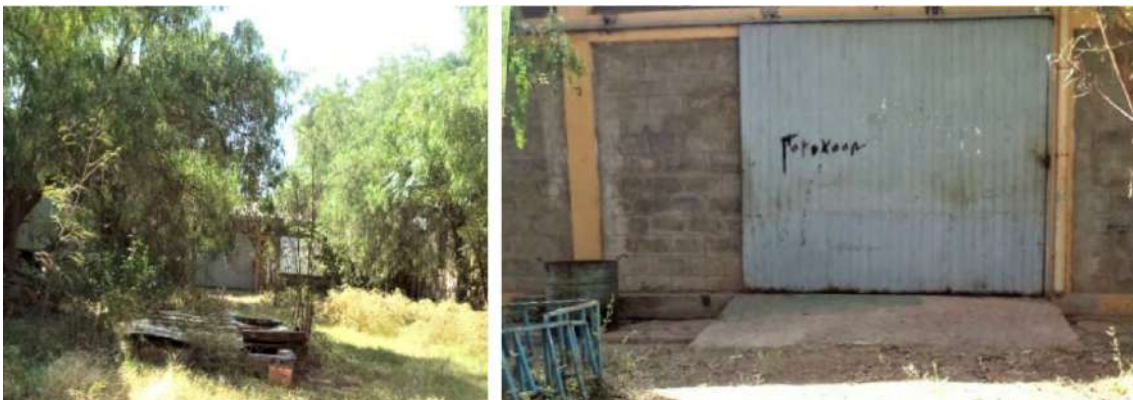
The workshop entrance has a ramp with a gradient of 17.5% (1.60m long for a rise of 0.28m, with a width of 0.36m width). The ramp has no handrail, kerbs or signage.

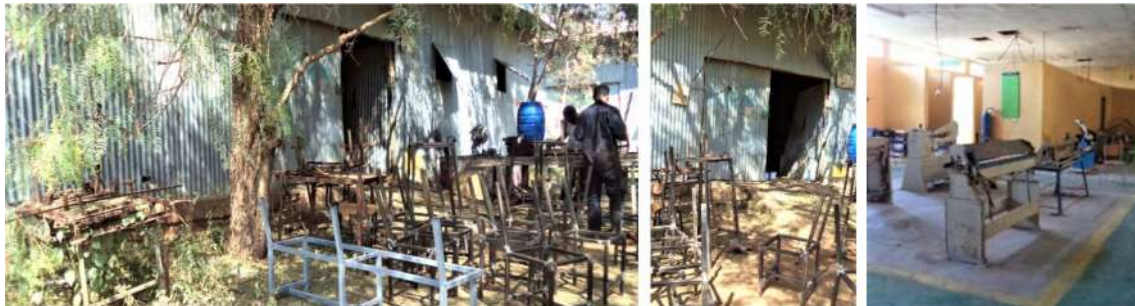
The entrance to the **production/demonstration workshop** is not well designed. The ramp has a gradient of 13% (2.60m long for a rise of 0.35m) and is 1.70m in width. It has no handrail or signage. The door is 3.00m wide and 2.70m high.

- Since the workshop has machinery and materials that could cause accidents, instructions and security information should be clearly displayed in a large lettering.

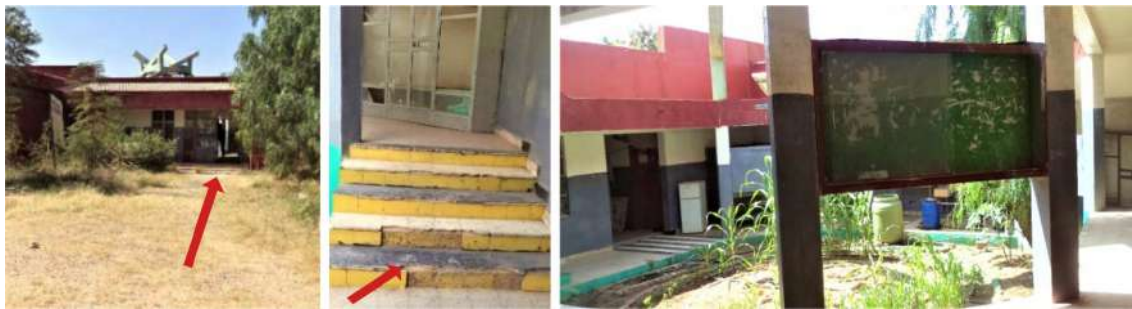
The Electronics Section is accessed by four steps, 0.16 high and with a tread width of 0.30m. This stairway has no handrail. Inside, the corridor is obstructed by tables, water tanks and boxes left lying around.

- All obstructions should be removed and the area thoroughly cleaned.
- The gulleys should be covered with appropriate materials.
- The Centre needs to be properly signposted and a sign erected beside the Centre at a reasonable height and in large lettering.
- Stairs should be replaced with ramps (5% gradient and with handrails at heights of 0.70m upper and 0.90m extending 0.30m beyond the start and end points of the ramps).
- Steps should not exceed 0.15m in height and their tread widths should not be less than 0.35m.
- Each step should be marked with a horizontal stripe, or the steps should be constructed in bright ceramic colours.
- The door should at least 0.80m wide and 2.10m in height.
- Door hands should not be more than 0.80m above floor level.

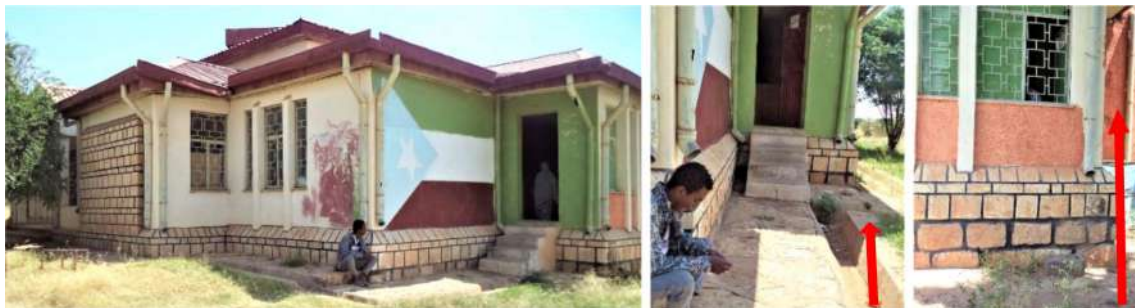
The service window for students is at a height of 1.85m above ground level. However, to access this window you have to negotiate a gulley which is 0.29m deep and 0.48m wide. The pathway is not level. Moreover, the window is not signposted.

- As always, clear signage is needed, suitably positioned and in bold lettering.
- The stairs should ideally be replaced by a ramp, with handrails at heights of 0.70m and 0.90m.
- Steps should not exceed 0.15m in height, with tread widths of no less than 0.35m.
- The door should be at least 0.80m wide and 2.10m high.
- The door handle should not be more than 0.80m above floor level.
- The service window should not be more than 0.70m above ground level. There should be clear signage and information in the upper part the window.
- Chair heights should be not more than 0.45m.

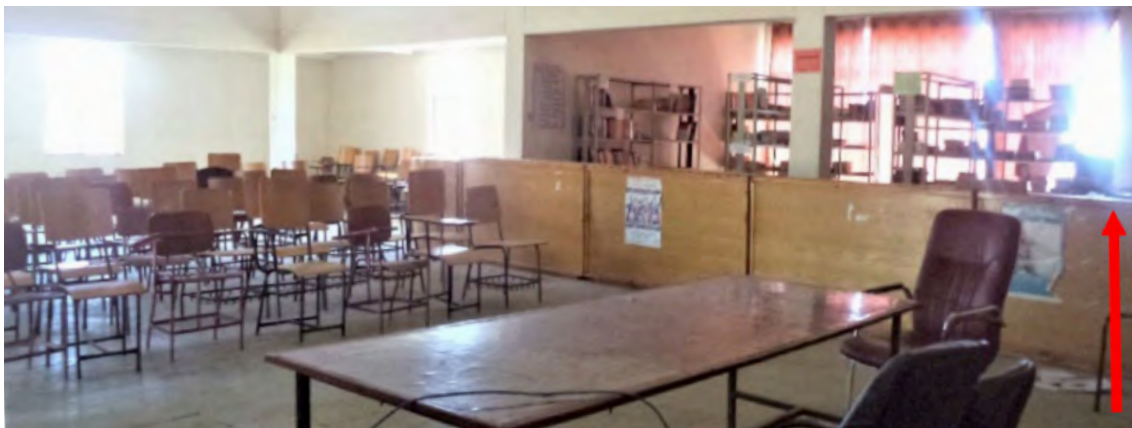
The chair and table heights are 0.43m and 0.72m respectively. The chairs are not cushioned. There are shelves at heights of between 0.50m and 2.00m. The library building has no smoke detector or fire extinguisher.

- Clear signage in bold lettering is required, as always.
  - Gulleys should be covered over with appropriate materials.
  - Chair and table heights should be not more than 0.45cm and 0.70cm respectively. We would recommend that the chairs be cushioned.
  - Bookshelves should be functional, located at heights of between 0.45m and 1.20m above floor level.
  - The building should be equipped with a smoke detector and a fire extinguisher.
-

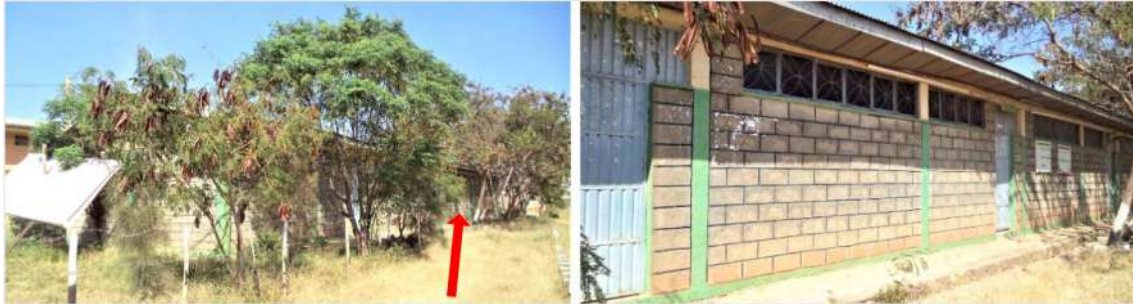
The path to the ICT room is not well laid out, nor is it level. The entrance door is 0.80m wide and 2.00m high, with a handle/lock at a height of 1.10m. The room is well lit, with a functional lighting system. The switch is located at a height of 1.50m above floor level. The tables are 0.70m high. The height of the reception desk is 1.50m; there is no space underneath for wheelchair-users' knees.

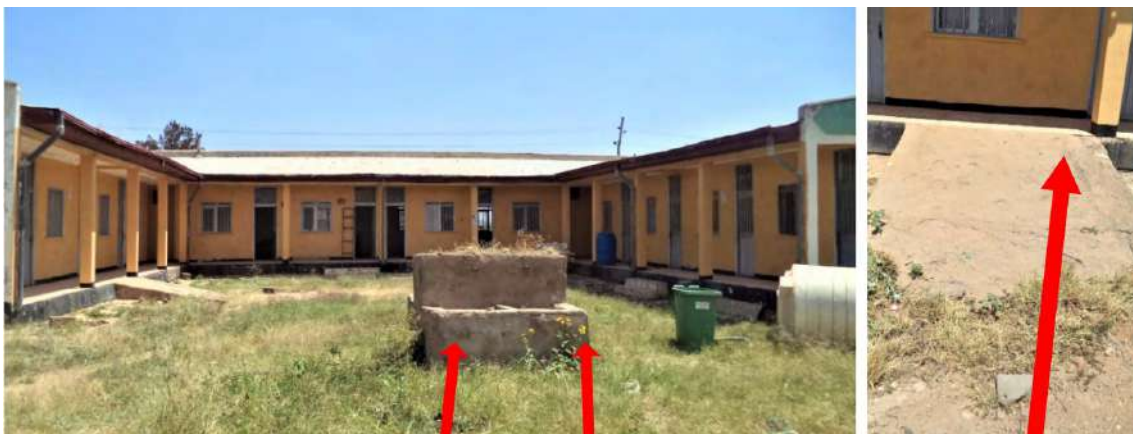
The dormitory was built with the intention of providing technical skills training for refugees from neighbouring Somalia. The route to the dormitory is not well laid out. There is no signage indicating the dormitory and its various services.

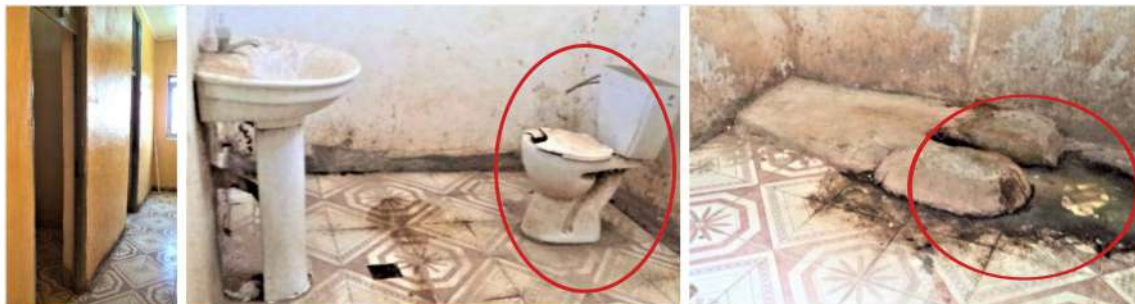
The hand washbasin is not functional. The basin stands at a height of 0.82m and is 0.84m wide (i.e. the distance to the water pipes/outlets). There is no space underneath for wheelchair-users' knees.

The rooms are all of the same size and design. The building is accessed by a ramp with a gradient of 16% (2.30m long for a rise of 0.37m) and is 1.44m in width. The ramp has no handrail or kerbing on either side. Moreover, there is no signage indicating the availability of the ramp. The width of the open walkway leading to the rooms is 1.30m. The doors to the dormitories are 0.80m wide and 2.00m high, with handles 1.00m above floor level. The toilets are located at a distance of less than 20m from each dormitory. They have no signage and are not kept clean. The toilet doors are 0.59cm wide and 1.97m high. The locks do not work properly. The cubicles measure 1.70m by 3.18m. The toilet seats, 0.45m above floor level, are designed for persons with disabilities. The washbasins are 0.77m off the ground.

- The pathways leading to the dormitory need to be levelled.
- There should be clear signage in bold lettering.
- The hand-washing facility needs to be at a reasonable height of between 0.60m and 0.80m above ground level.
- The washbasin should be working properly at all times; there should be space under the basin to a height of between 0.40m and 0.65m.
- The ramp should have a gradient of 5% (it needs to be 7.4m in length for a rise of 0.37m), a width of at least 0.90m and handrails at heights of 0.70m and 0.90m.
- Since there is a ramp, there should be a sign indicating its availability along the pathway or by the gate.

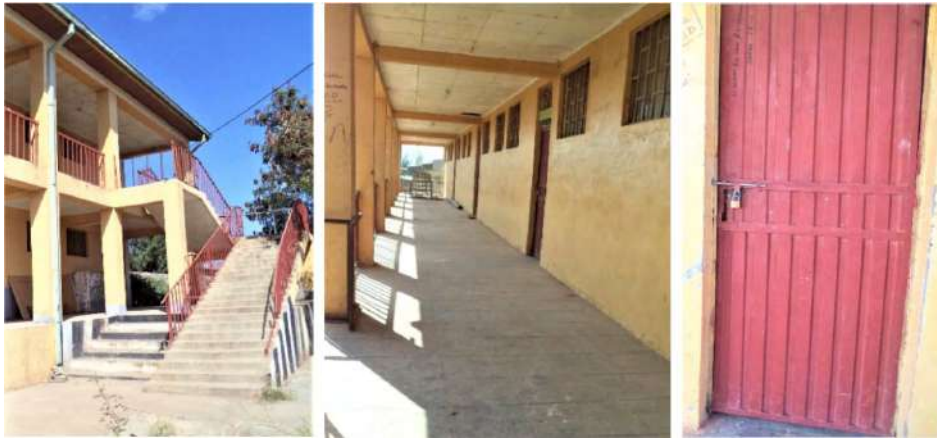
## Access to the 1st-floor dormitory rooms

The first floor has its own staircase of 30 steps. These range from 0.10m to 0.15m in height and from 0.24m to 0.28m in tread width. There is a handrail at a height of 0.90m but it is inadequate.

- The steps to the ground floor should ideally be replaced by a ramp. In any case, there should be handrails located at heights of 0.70m and 0.90m.
- The steps should not be more than 0.15m height and the tread widths should not be less than 0.35m.

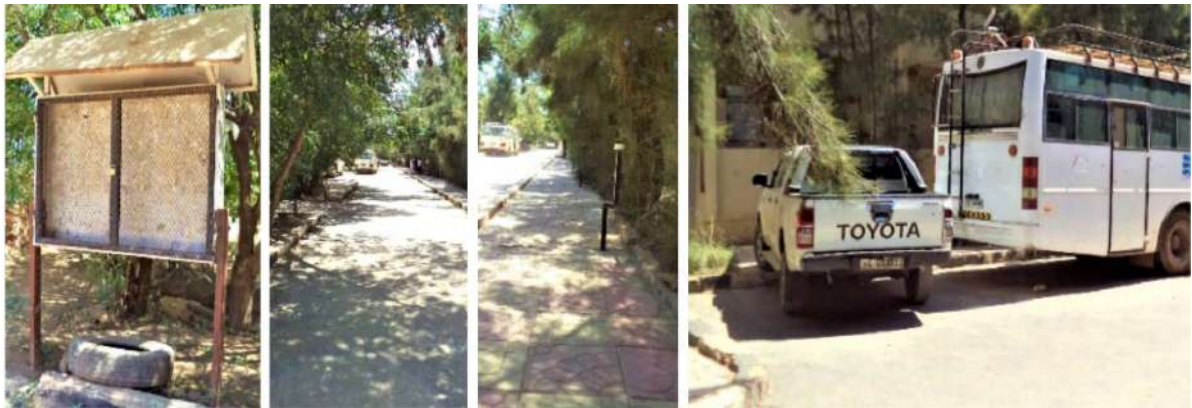
The pedestrian pathway is level, 1.60m wide and has kerbing 0.06m in height for protection. However, on the right-hand side it is obstructed by overhanging trees and lamp posts. In some places the surface is cracked for various reasons. The direction indicator is poorly located. This sign (an arrow) is 0.50m wide and placed at a height of 1.47m.

- The complex needs to have clear and visible signage, providing information and giving directions.
- Signs with arrow-type direction indicators should be at least 2.10m above the ground for safety reasons.
- The vehicle route should have speed bumps and safety information (speed limit signs).
- The car parking area needs to have an appropriate sign .
- The pathway should be free of obstructions such as lamp posts and overhanging trees.
- The kerbing along the pathway should be 0.10m in height.
- The cracked areas needs to be leveled and repaired.

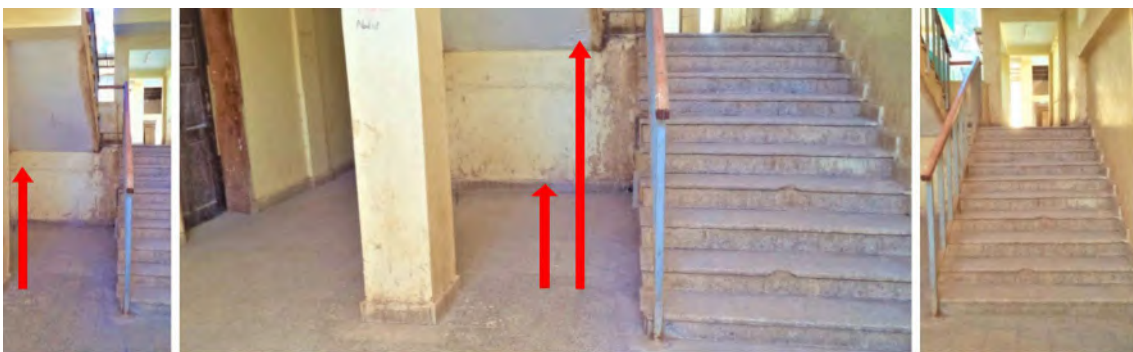
The first flight of steps to the first floor has 10 steps, the second nine steps. Beside the staircase is an empty space whose ceiling reduces in height from 2.60m to 0.50m. This space is not closed off or protected and could be a hazard for persons with disabilities when walking around. The stair has a handrail to the left-hand side, as a height of 0.80m. The steps are 0.15m high with a tread width of 0.32m. The staircase itself is 1.60m wide.

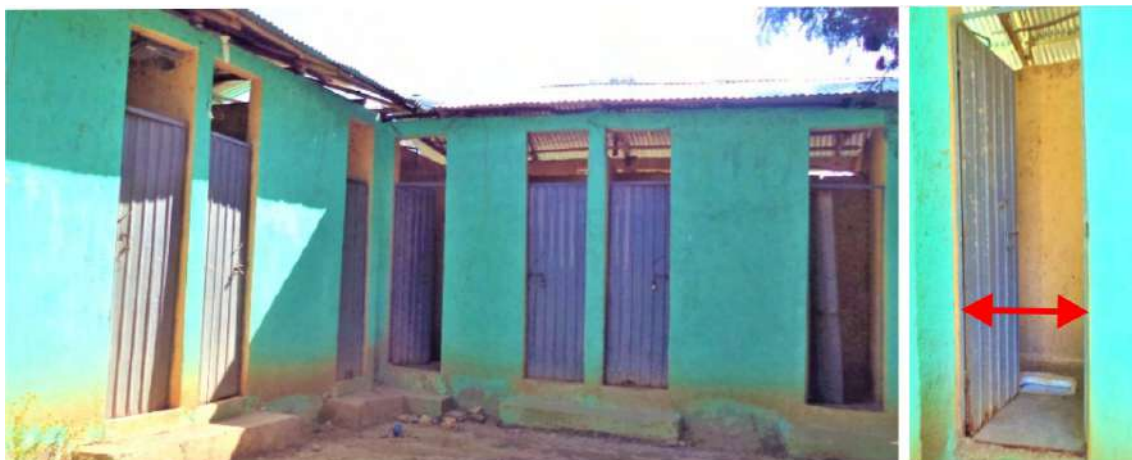
The toilets designed for ladies are located close to the Female Dormitory building on the right-hand side. The toilets are separate from the main building (at a distance of 100m) to avoid the problem of bad odours in the dormitories. However, there is no proper pathway to the toilets and they are not signposted. The toilet cubicles are accessed by two steps of between 0.14m and 0.24m in height. The doors are all designed and constructed in the same way: 0.60m wide and 2.00m high with handles at a height of 1.00m. The handles/locks that are not broken are easy to manage. The cubicles measure 1.30m by 1.15m. The toilet platforms (hole-in-the-floor type) are 0.30m square, leaving a space of 0.70m to the front, 0.30m to the back and 0.40m or 0.45m on either side. There are no grab bars for support beside the toilet platforms.

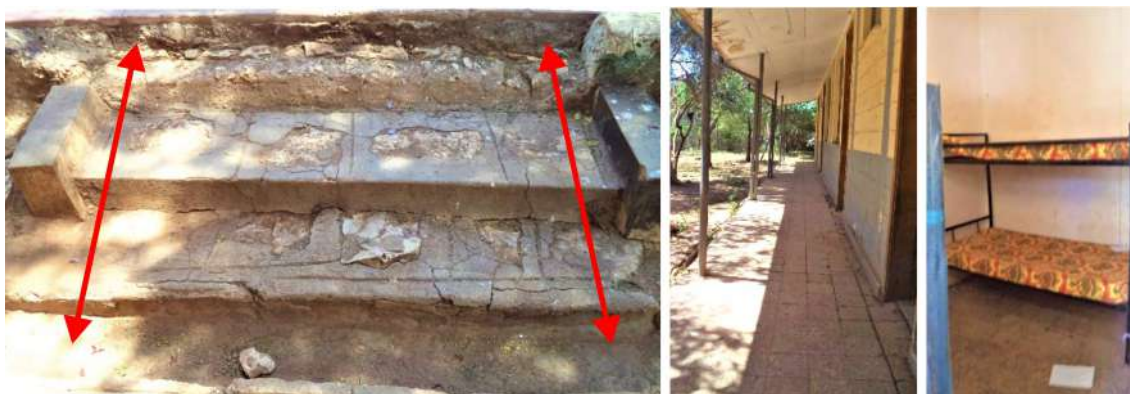
The walkway is 1.35m wide; it has no kerbing or protection on the open side. The dormitory rooms are all the same: doors 0.70m wide and 2.02m high with handles/locks at a height of 1.00m. Inside the rooms, most of the lights are not functional and it is rather dark. Many of the lockers are broken. The beds are bunk beds, 0.55m high, 1.82m long and 0.90m wide. The lockers are positioned at heights of between 0.45m and 1.20m above floor level. The light switches are located at a height of 1.35m.

- Clear signage is required.
- The steps should be replaced by a ramp, or at least the existing steps should be equipped with handrails at heights of 0.90m and 0.70m.
- The steps should not be more than 0.15m high with tread widths of no less than 0.35m.
- In order to make the walkway along the building safe, we strongly recommend that it be fenced in with handrails or that kerb stones be installed to a height of 0.10m.
- The doors should be at least 0.80m wide and 2.10m high.
- The door handles should not be more than 0.80m from the ground.
- The dormitory rooms should be equipped with a functional lighting system.
- The students' lockers should be repaired and made functional.
- The beds should be between 45cm and 50cm high, and 2.10m in length. The upper bunks can be assigned to persons with hearing impairments.
- The light switches should not be more than 1.20m above floor level.

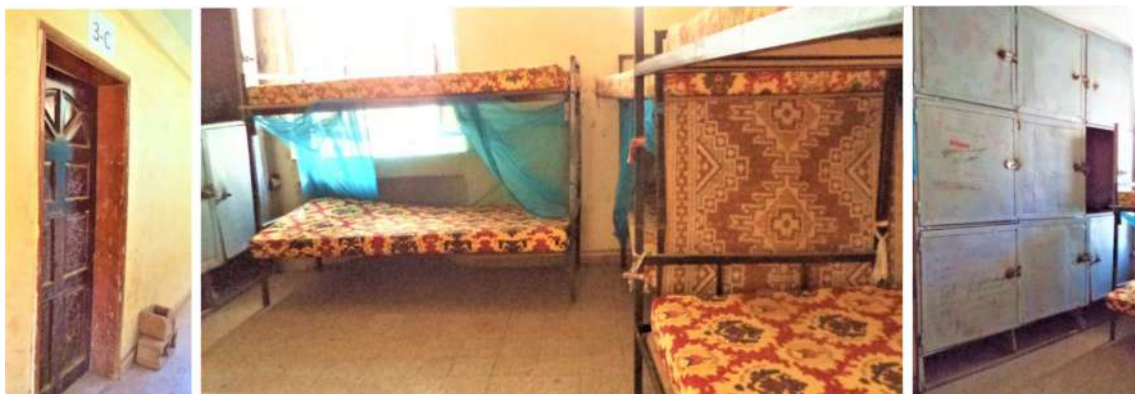
The dormitory rooms are all designed and built to the same standard. The corridors are 1.10m wide. The doors to the rooms are 0.80m wide and 2.10m high. Some of the handles and locks are broken. The signage is visible but not of good quality and easily erased. The door handles are located at a height of 1.10m. Most of the rooms are rather dark. However, there is a lighting system for each room and the switches are located at a height of 1.40m above floor level. The beds are bunk beds to make the best use of the available space. The lower and upper bunks are 0.50m and 1.35m high and 0.70m in width. There are no ladders or steps to access the upper bunks. There are lockers located at heights of between 0.70m and 2.70m.

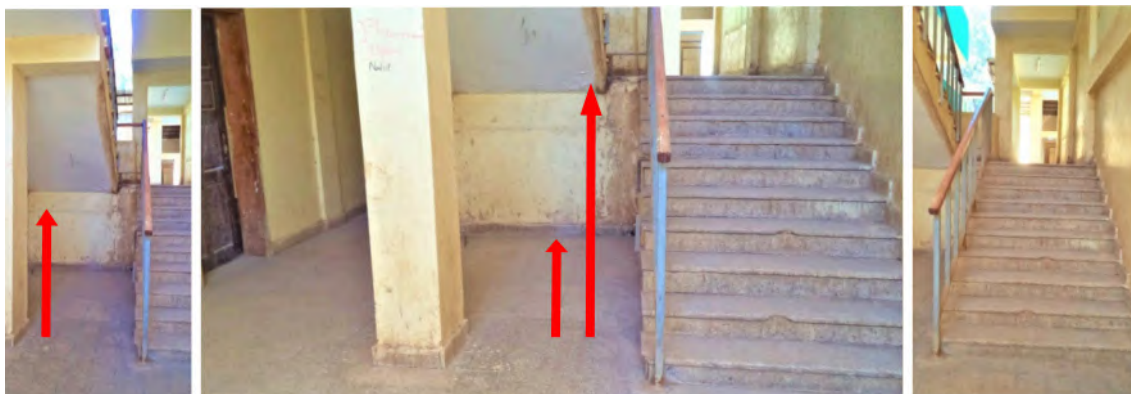
Flights of 10 steps lead to the first floor. The steps have a tread width of 0.30m and are 0.15m high. These stairs have handrails at a height of 1.10m height on the left-hand side. Again on the left-hand side of the staircase, there is an empty space 3.00m wide and with a ceiling height of 1.50m, which is not closed off. There is a pillar in the centre of the corridor forming another obstruction.

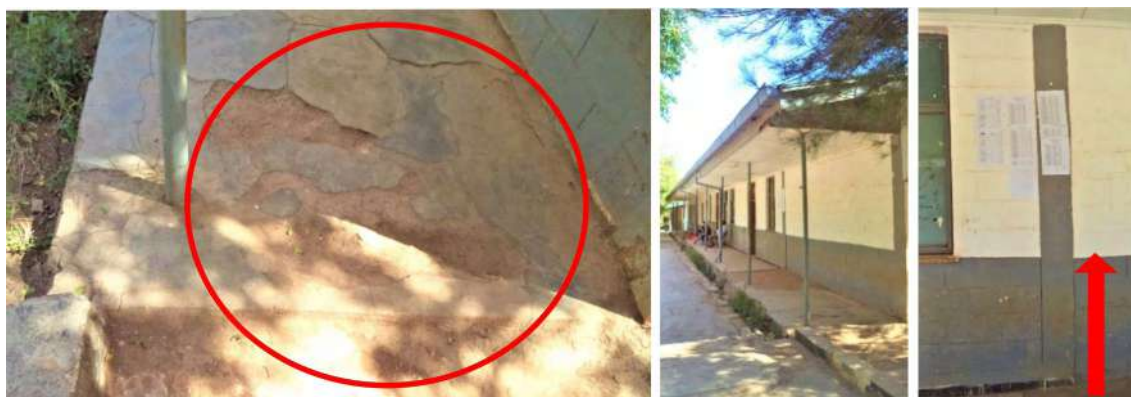
All the classrooms are at ground level, each with the same structure and design. The classroom block is close to the main road, inside the college complex to the right of the access way. The open walkway giving access to the classrooms is cracked in places. The width of the walkway is 1.35m; it has no kerb stones. The notice board is located at a height of between 1.70m and 2.20m; the notices themselves are in too small a font. The classroom windows are at a height of 1.05m above ground level. The doors are 0.75m wide and 2.00m high, with handles at a height of 1.17m. The light switches are 1.37m above floor level; the lights are not working properly. The whiteboards are fixed at a height of between 1.30m and 2.20m.

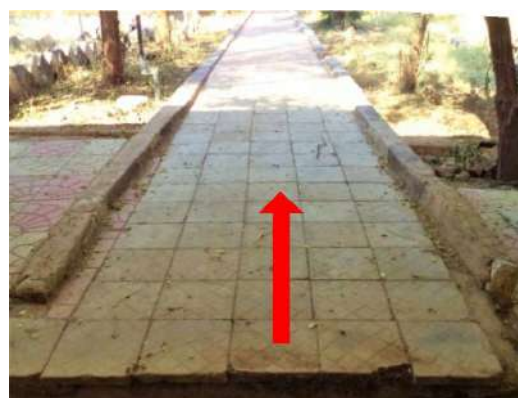
In front of the classroom block is a pathway, 2.00m wide, leading to an outdoor examination area. The pathway has no kerbing or handrails for protection and is not kept free of obstructions.

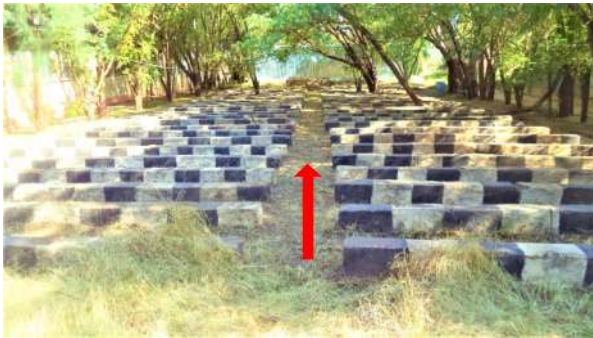
## Access to the outdoor examination area

The examination area is accessed by steps ranging from 0.20m to 0.40m in height. The seating consists of long painted concrete blocks, between 0.20m and 0.30m in height, laid out horizontally on either side of a narrow passage way (0.78m). There is no designated path for accessing the area, which is surrounded by gulleys and steps.

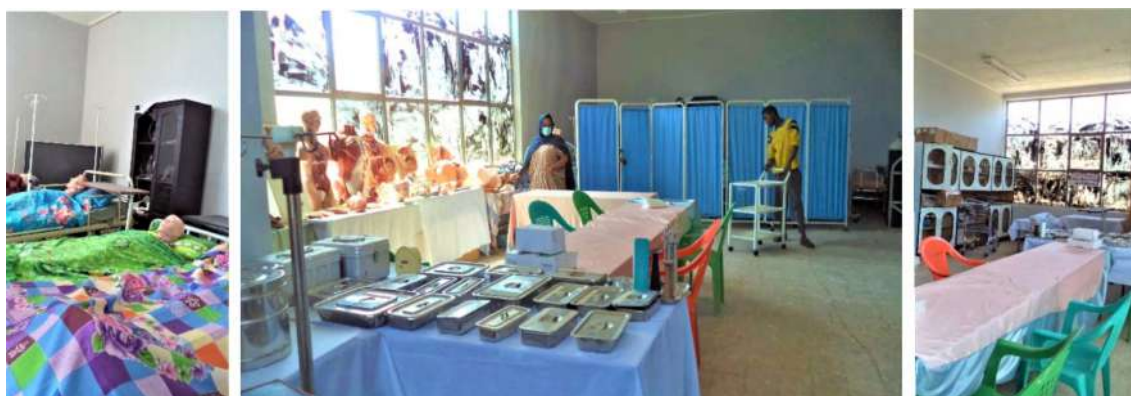
The walkway is 1.70m wide, with no kerbing or handrail protection on the open side. Each demonstration room has a double door 0.93m wide and 2.00m high, with handles/locks 1.00m above ground level. The rooms are very well lit and have a functioning lighting system. The switches are located at a height of 1.20m. The safety signage, illustrations, instructions and procedures are inadequate. The chairs and tables (0.42m and 0.72m respectively) are made of plastic. The examination tables are adjustable, from 0.40m to 0.70m in height, and 2.00m long. The standing cabinets are 1.70m high. The storage cabinets for consumables and materials are 2.00m above floor level.

*NB: During our audit, the Medical Demonstration Centre was being restructured and renovated.*
