Increased Application of Labour-Based Methods through Appropriate Engineering Standards

Uganda Country Report

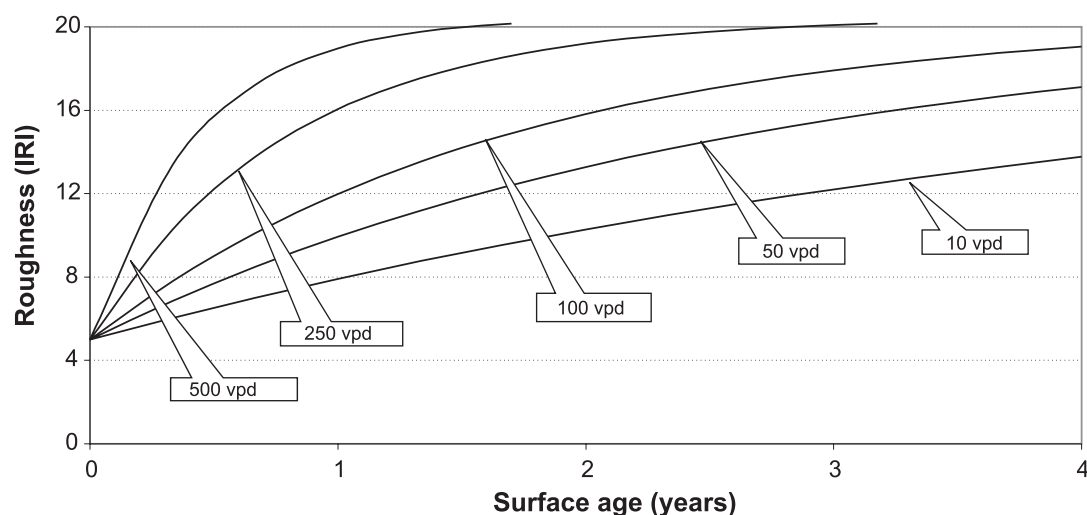
Figure 6.2
Roughness progressions on unsealed roads with no maintenance

The roughness progression relationship given above was derived using observations from roads under repeated grading cycles with no special compaction. The rates of roughness progression after construction or rehabilitation with full mechanical shaping and compaction were observed to be much slower than given by this model.

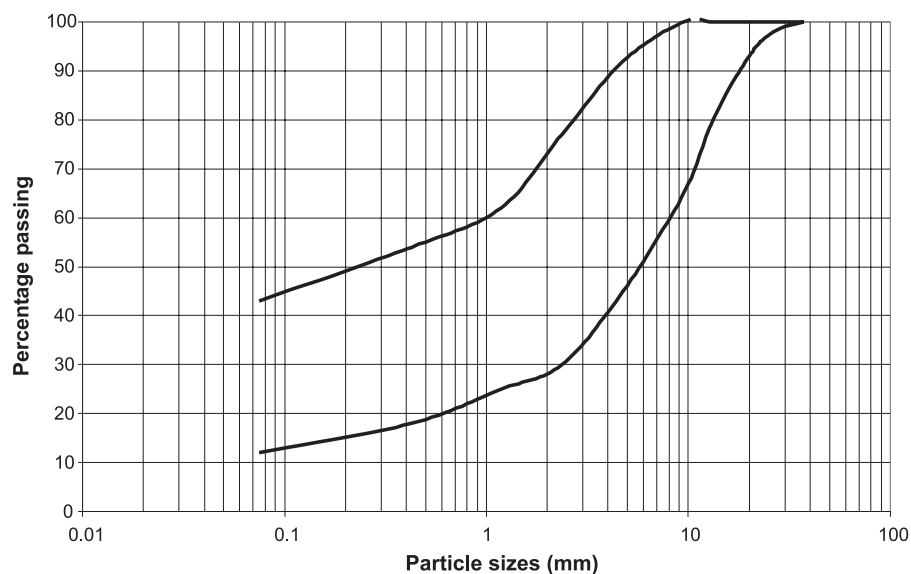
Figure 8.2
Recommended new grading envelope

- ❖ The results indicated that a wider grading envelope could be adopted for the wearing course with Grading Modulus (GM) in the range $1.56 < GM < 2.40$. This will enable finer materials to be used.
- ❖ Roughness values were generally approximately 20% lower than predicted by HDM.
