# ► Institutional review in preparation for improving access to TVET programmes for persons with disabilities who have been internally displaced

Final report submitted to the  
International Labour Organization (ILO)  
Submitted by the Ethiopian Center for  
Disability and Development (ECDD)

October 2020

### ► Physical accessibility audit of Jigjiga Polytechnic College

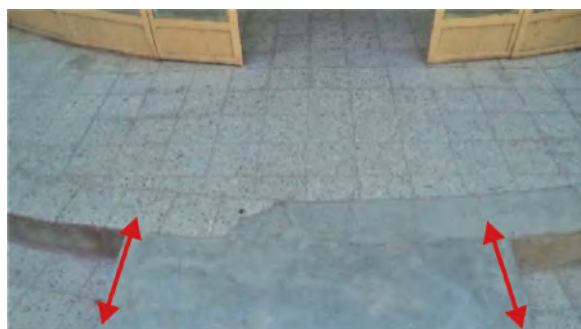
There is an entrance ramp with a gradient of 16.8% (1.90m in length for a rise of 0.32m and 1.37m wide). The ramp has no handrail or kerb curb stones for protection. There is no colour-contrasted strip at the top of the ramp. Additionally, there is no signage indicating the availability of the ramp for wheelchair and crutch users.

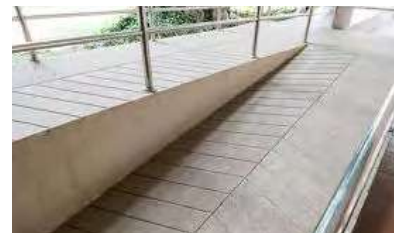
The ramp giving access to these workshops and offices is well constructed and slip-resistant. It has a gradient of 20.7% (3.70m long for a rise of 0.75m and 1.45m wide). The ramp has no handrail, kerb stones or signage.

- The ramp at the entrance to the right-hand corridor needs to be constructed with a gradient of 5% (for a rise of 0.75m, the ramp will have to be at least 15m in length). It should be 0.90m in width, with handrails at heights of 0.70m and 0.90m from the ground.

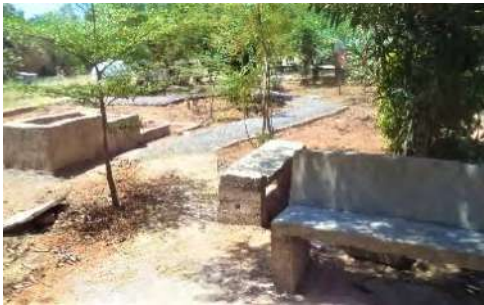
The paths to the office building are not sufficiently level and are not adequately signposted. The grassy area to the left of the main access to the administrative building has open-air seating and chairs with a height of 0.42m. The walkway through the green area is 1.10m in width with no kerbs or handrails.

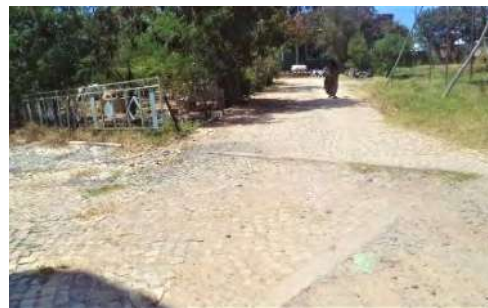
There are no signs indicating the way to the Administrative Office. Immediately in front of the entrance there is a gully, which is 0.16m deep and 0.30m wide. There are three steps up to the office building varying in height from 0.15m to 0.20m and with tread widths of between 0.28m and 0.29m.

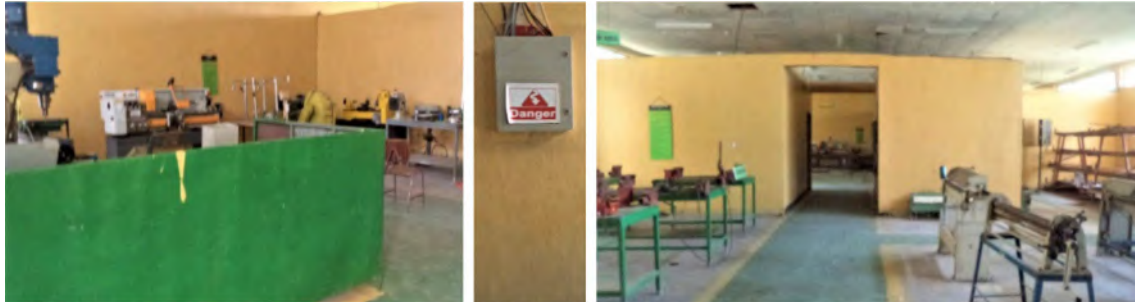
The entrance to the **production/demonstration workshop** is not well designed. The ramp has a gradient of 13% (2.60m long for a rise of 0.35m) and is 1.70m in width. It has no handrail or signage. The door is 3.00m wide and 2.70m high.

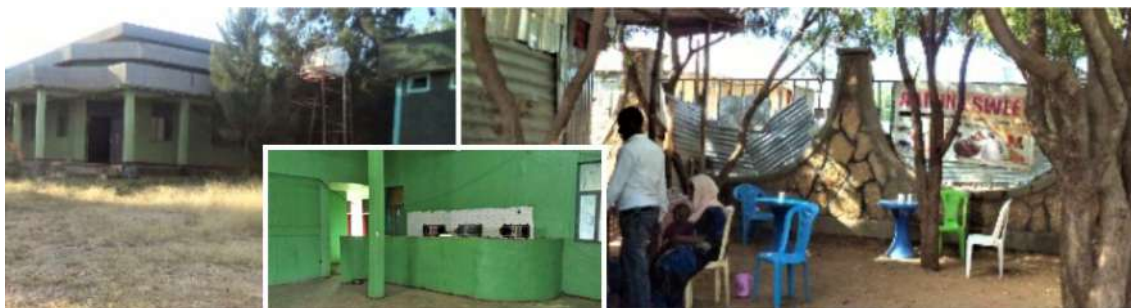
The other cafeteria, near the main gate, has plastic chairs with a seating height of 0.43m and tables with a height of 0.70m.

- The cafeterias should have clear signage above the entrance in a reasonable font size.
- There should be also level and clearly signposted pathways leading to the cafeterias.
- The steps up to the cafeteria behind the Administrative Office should be of uniform height (0.15m) and tread width (0.35cm) and there should be handrails fixed at heights of 0.70m and 0.90m.
- The doors should be at least 2.10m high.
- The pillars of the cafeteria behind the Administrative Office should be shielded with protective material to a height of 0.45m.
- The hatch through which food is passed and counter should be at a height of 0.70m.
- The seating of the chairs should be 0.45m above ground level.

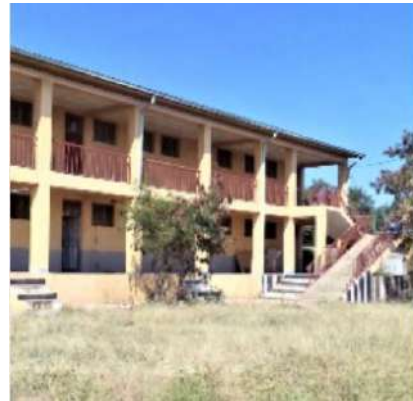
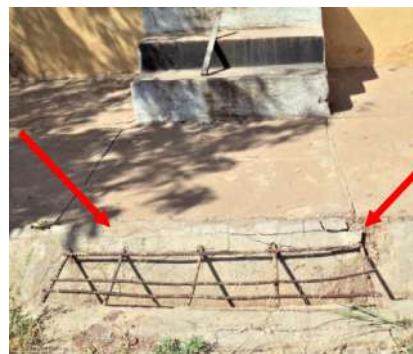
As you approach the building, there is a gulley 0.47m deep and 0.34m wide. This gulley is bridged by metal plates 0.47m wide, with spaces/gaps of 0.20m between each row. This is hazardous for persons with disabilities or impairments.

The ground floor rooms and services are accessed by a flight of five steps, which are 0.18m high and have a tread width of 0.30m. There is no handrail on either side. The walkway around the building is 2.15m in width.

- The steps to the ground floor should ideally be replaced by a ramp. In any case, there should be handrails located at heights of 0.70m and 0.90m.
- The steps should not be more than 0.15m height and the tread widths should not be less than 0.35m.

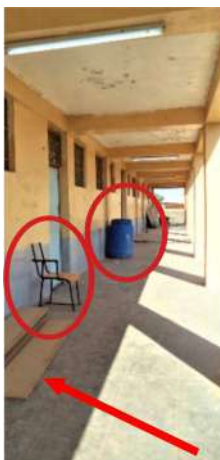
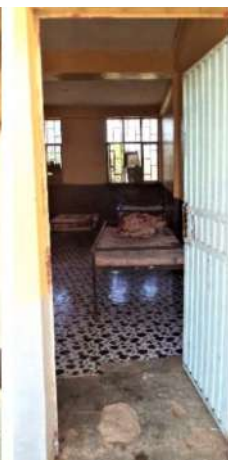
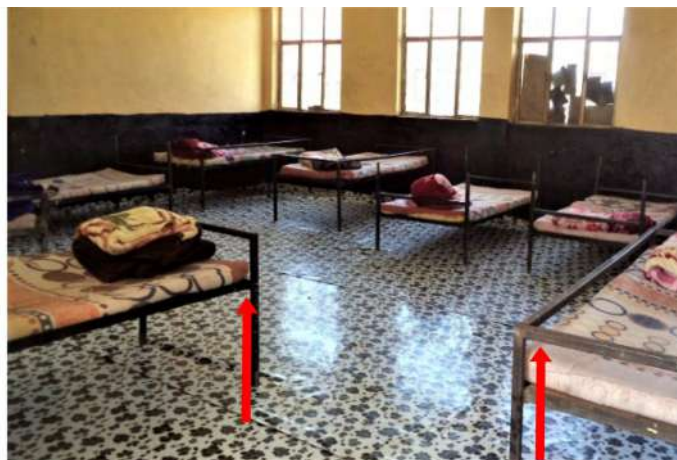
The doors are not painted and carry no signage. The doors are uniform in size: 0.83m wide and 2.06m high, with handles/locks at a height of 1.10m. Many of the locks were not functional at the time of our audit. Since the windows are painted over in different colours, the rooms are well enough lit. The light switches are located at a height of 1.40m above floor level. The beds range in height from 0.36m to 0.70m and in width from 0.65m to 1.94m.

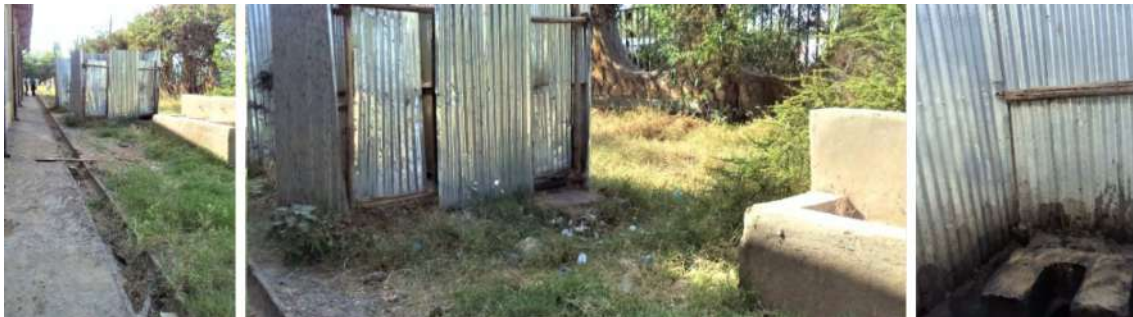
The toilet building is constructed of corrugated iron. Each cubicle is 1.40m in width. The toilet platforms (hole-in-the-ground type) are located at 0.20m from the rear wall and 0.90m from the entrance door. The doors have no locks on the inside.

The hand-wash facility is not functional at the moment. The tub is 0.56m high and 0.77m wide (the distance to the water delivery pipe). There is no space underneath to allow access for wheelchair users.

- The way to the toilets should always be clearly signposted.
- The pathway should be at least 1.50m wide with a handrail or kerbing to a height of 0.15m.

- There should be a washbasin, located at a height of 0.70m.
- There should be a space to a height of between 0.40m and 0.60m under the basin to accommodate a wheelchair-user's knees.

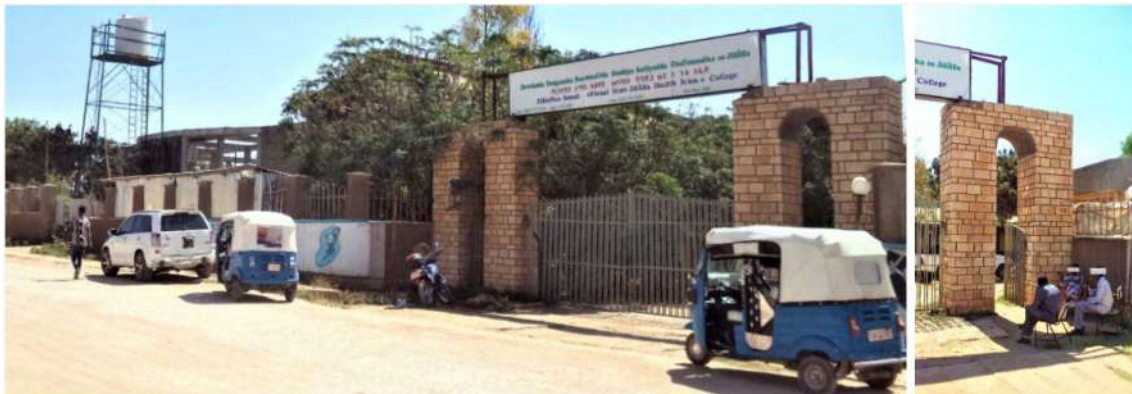
The entrance gate is just 4.00m from the road. However, there is no signage on the approach to the College.

There is a sign in contrasting colours over the main gate, but it has no electric lighting. The gate has three entrance ways, but the left-hand entrance is not in use. The remaining two entrances are used by the college community: the central gate for the passage of vehicles, the entrance on the right for pedestrians. The area is not entirely level. The pedestrian entrance is 0.96m wide and 4.00m high. The main gate is 6.00m wide and 4.00m high.

- There needs to be clear signage on the main road leading to the college, starting from the city centre.
  - There should signage at a reasonable height and in clear lettering by the roadside on the approach to the College.
  - There needs to be a functional lighting system at the main entrance.
  - Both pedestrian entrances should be in use to avoid unnecessary crowding.
  - The surface at the entrance, for vehicles and pedestrians, needs to be leveled.
  - The pedestrian entrances should be at least 1.00m wide.
-

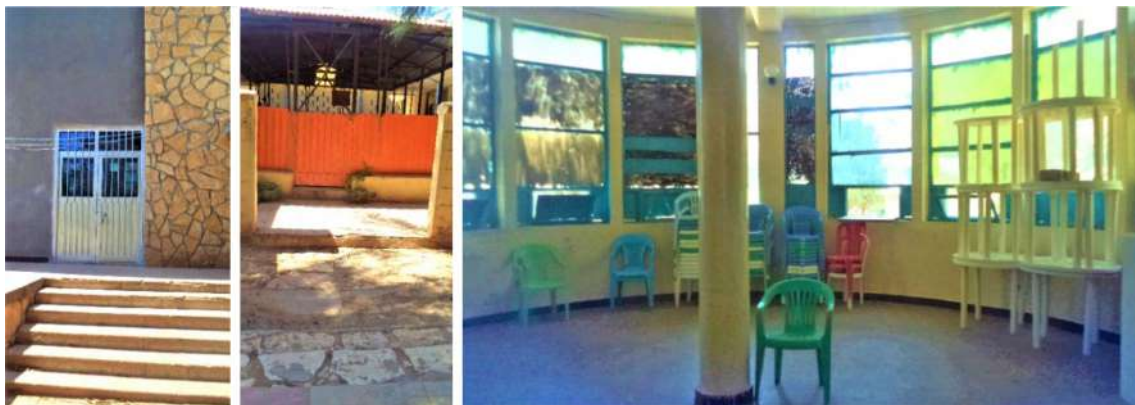
The cafeteria is not signposted. The paths leading to it are uneven. One pathway has two steps, 0.10m high with a tread width of 0.21m. The second pathway, also uneven, is 1.25m wide and has kerbing to a height of 0.15m. The cafeteria has no clear and visible signage. It is accessed by a flight of six steps ranging in height from 0.09m to 0.14m, with tread width of 0.26m. The door to the cafeteria is 1.50m wide and 2.10m high. The door handle is located at a height of 90cm. The doorway has a threshold 0.05m in height. Inside the cafeteria, the tables and chairs are made of plastic, measuring 0.73m and 0.42m above floor level respectively.

- Clear signage and direction indicators are needed, in bold lettering.
- The steps giving access to the cafeteria should have handrails at heights of 0.90m (upper handrail) and 0.70m (lower handrail), extending 0.30m beyond the start and end points of the steps.

- The paths should be made level.
- Ideally, stairs should be replaced by ramps (with 5% gradient and handrails at heights of 0.90m and 0.70m extending 0.30m beyond the start and end points of the ramps).

- Steps should not be more than 0.15m in height, with tread widths of no less than 0.35m.
- Each step should be marked with a horizontal stripe in a bright colour.

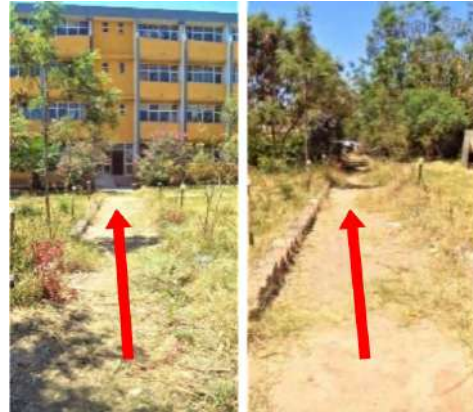
The Female Dormitory is located behind the Somalia Cafeteria. The pathway is uneven and not free of obstructions. It is 1.95m wide with kerbing 0.10m in height. There is no signage indicating the way to the dormitory building.

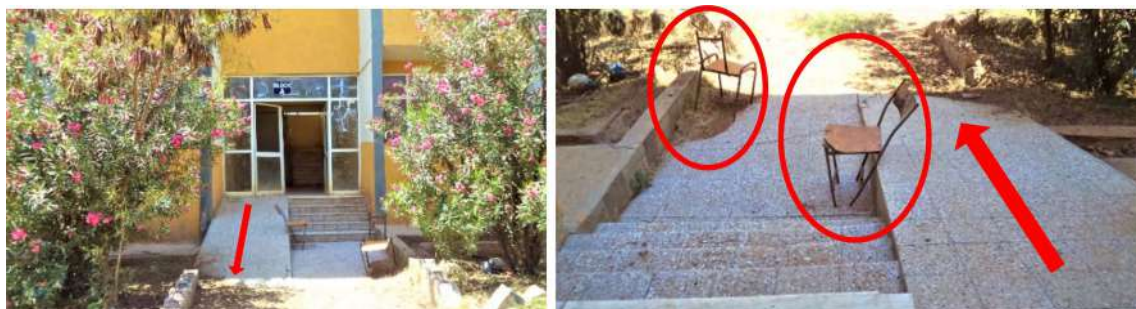
There are two means of access: a ramp and a flight of steps. The ramp has a gradient of 20% (4.00m long for a rise of 0.8m) and is 1.55m wide. The ramp has no handrail or kerbing. The stairway consists of five steps, each 0.16m high with a tread width of 0.28m.

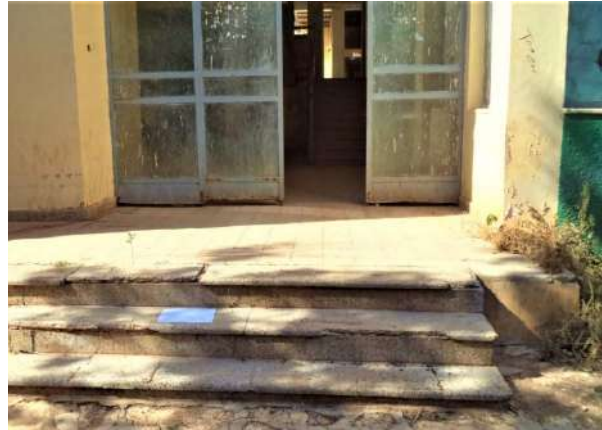
Again, this dormitory is not clearly signposted and there is no designated route or pathway to it. The main entrance is accessed by a flight of three steps 0.14m high with tread widths of between 0.29m and 0.30m. There are no handrails. The steps are well constructed of non-slip materials. The double doors are 1.60m wide in total (0.80m each door) and 2.10m high. There is no proper door handle.

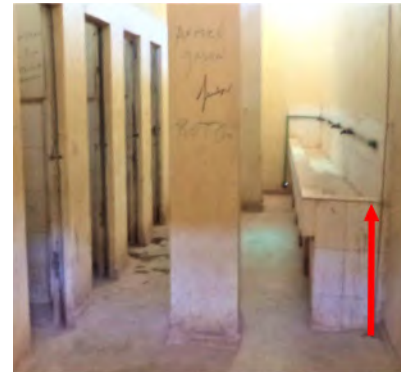
The toilets are located between the two dormitory buildings. Again, there is no clear signage. Access to the toilets is down a flight of five steps 0,27m in height with tread widths of 0.15m. There are no handrails or kerb stones to make the steps safe. The door leading to the toilet corridors is 0.65m wide and 2.10m high. It is an open door.

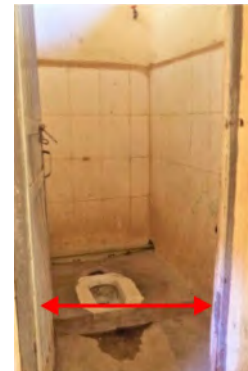
Inside the building, the second door giving access to the toilet cubicles is 0.62m wide and 2.06m high. The doorhandle/lock is located at a height of 1.17m. Each cubicle has the same design and structure and measures 1.30m by 0.92m. The toilets are of the hole-in-the-floor type, a platform in the floor with no seat or back support.

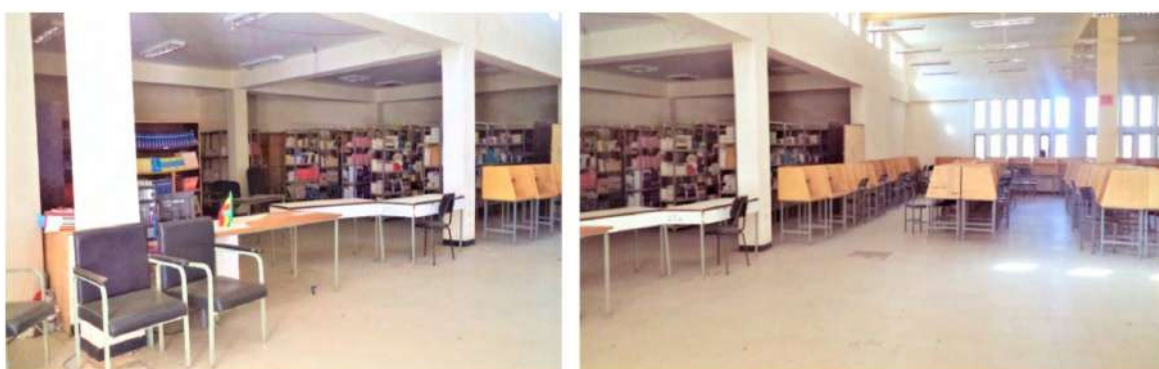
There is no clear signage indicating the location of the library. The building is accessed by a flight of four steps 0.15m high and with tread widths of 0.32m. There is no handrail or kerbing. The double door is 1.46m wide (0.67m and 0.79m) and 2.06m high. The room is well lit, with the light switch at a height of 1.37m. The visitors' chairs have arm rests; the seats are 0.45m above floor level. The students' tables and chairs are 0.47m and 0.77m high respectively. The library computers used by students have no JAWS software. The room does not have a smoke detector or fire extinguisher.

- There needs to be clear signage in bold lettering signposting and advertising the library.
  - The steps should not be more than 0.15m in height, with a tread width of no less than 0.35m.
  - The steps should be fitted with handrails at heights of 0.90m and 0.70m.
  - The door should be at least 0.80m wide and 2.10m high.
  - The door handles should not be more than 0.80m above ground level. Please ensure that they functional and easy to operate.
  - The light switch should not be more than 1.20m above floor level. The room needs to be well lit.
  - The seats of the library chairs should be at a height of 0.45m; the tabletops no more than 0.70m above floor level.
  - The computers serving persons with disabilities should have JAWS software installed.
-

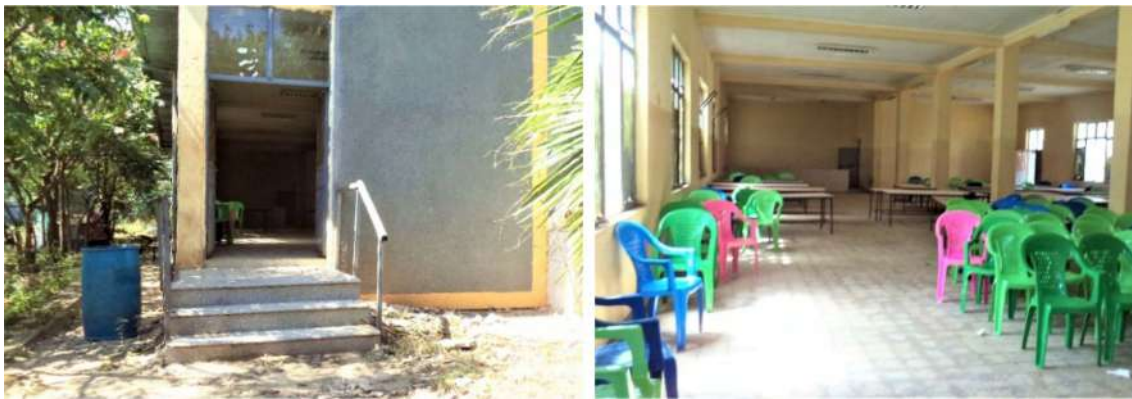
During the assessment, we discovered that the College does not have an adequately sized meeting hall. The existing meeting room is accessed via a flight of three steps 0.18m in height and with tread widths of 0.30m. There is a handrail on the right-hand side of the steps, 1.00m in height from the ground. The door is 0.75m wide and 1.90m high, with the handle/lock at a height of 1.17m. The light switch is 1.37m above floor level but the lights are not functioning properly. The meeting hall chairs (0.42m) and tables (0.73m) are made of plastic.

- The route leading to the steps should be level and kept free from obstructions.
  - The steps should not be more than 0.15m high, with tread widths of no less than 0.35m.
  - The stairs should be fitted with handrails (at heights of 0.90m and 0.70m) on both sides. The handrails should extend at least 0.30m beyond the bottom and top of the steps.
  - The door handle should not be more than 0.80m off the ground; it should be possible to operate the handle with minimal force (no more than 2kg).
  - The light switch should be located at a height of 1.20m.
  - The seats of chairs should not be more than 0.45m above floor level, tabletops no more than 0.70m.
-

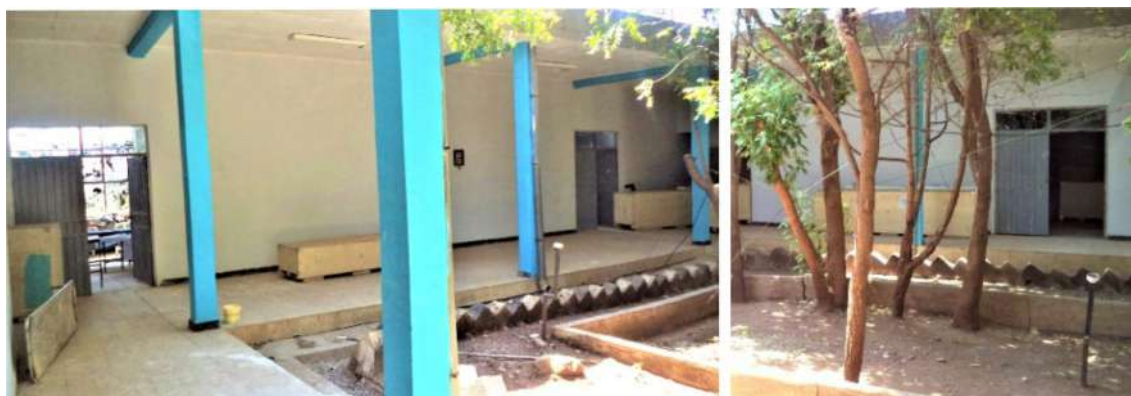
The Demonstration Centre is not clearly signposted. Moreover, the access route is not well laid out or level. The existing pathway is 1.50m wide. There are two steps (0.21m high, tread widths 0.32m) up to the open walkway giving access to the various rooms. There are no kerb stones or handrails to ensure safety.

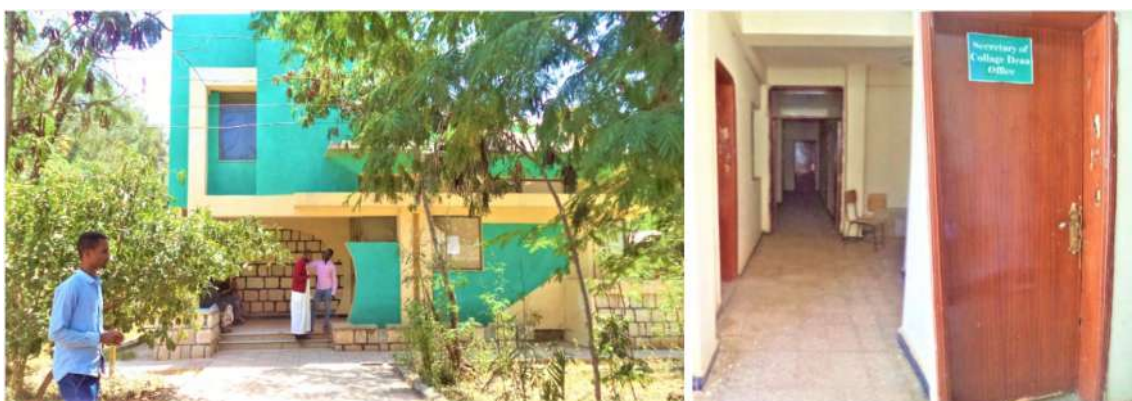
The Dean's Office is not clearly signposted for visitors. The access way is 3.10m wide and level, but the surface is not slip-resistant. The entrance is accessed by two steps (0.16 m high, tread width 0.30m), with no handrail on either side.

The interior corridor is 1.20m wide and poorly lit. The office door is 0.70m wide and 2.10m high, with the handle at a height of 1.10m. The office itself is very well lit and the floor is covered with non-slip mats. The guest chair (0.44m) is cushioned; the height of the table is 0.70m.

- The Dean's Office should be well signposted, starting from the main gate.
  - The surface of the access route should be of slip-resistant material.
  - The entrance should be accessible via a ramp (standard 5% gradient, 0.90m wide, handrails at heights of 0.70m and 0.90m).
  - The steps should be 0.15m high with a tread width of 0.35m and equipped with handrails at heights of 0.70m and 0.90m.
  - The corridor should be adequately lit
  - The door should be at least 0.80m wide and 2.10m high.
  - The door handle should be no more than 0.80m above floor level and should be fully functional.
  - The light switch should be located at a height of 1.20m.
-

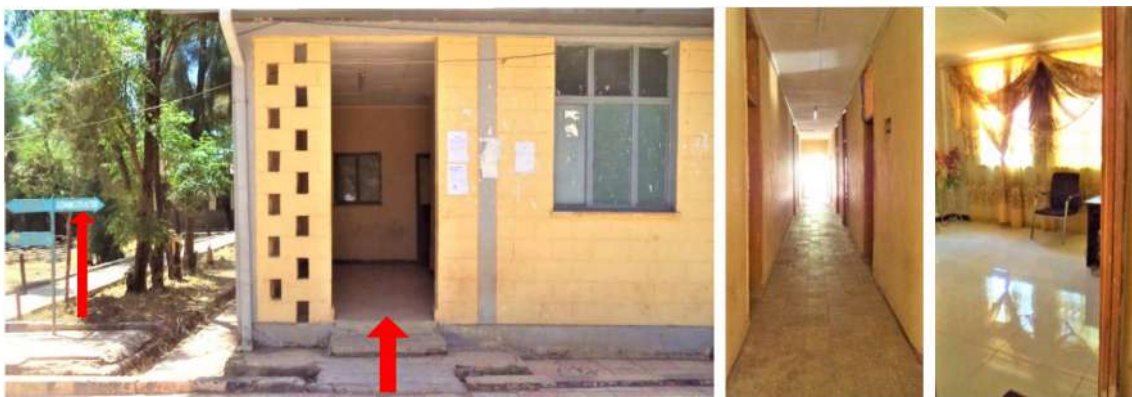
The route to the College's Administrative Office is well signposted, with an arrow sign 0.50m wide at a height of 1.50m. In front of the entrance there is a gulley bridged by a concrete slab 1.30m in width. Access is by two steps 0.13m in height with tread width of 0.30m. The offices all have the same architectural design and measurements.

Along the interior corridor, there is no clear or visible signage. The corridor is 1.30m wide. The office doors are 0.75m wide and 2.06m high, with handles placed at a height of 1.00m. The heights of the chairs and tables are 0.42m and 0.72m respectively.

- Signs need to be at a height of at least 2.10m above ground level.
  - A ramp should be provided for access to the building (5% standard gradient, 0.90m wide and with handrails at heights of 0.70m and 0.90m).
  - The steps should be 0.15m high with a tread width of 0.35m and there should be handrails at heights of 0.70m and 0.90m.
  - The office doors should be at least 0.80m wide and 2.10m high.
  - The chair and tables heights should be not more than 0.45cm and 0.70cm respectively.
-
